Welcome to Restoring Antique Radios: The 1931 Cathedral Philco Model 20

The first steps in restoring and/or repairing an antique radio

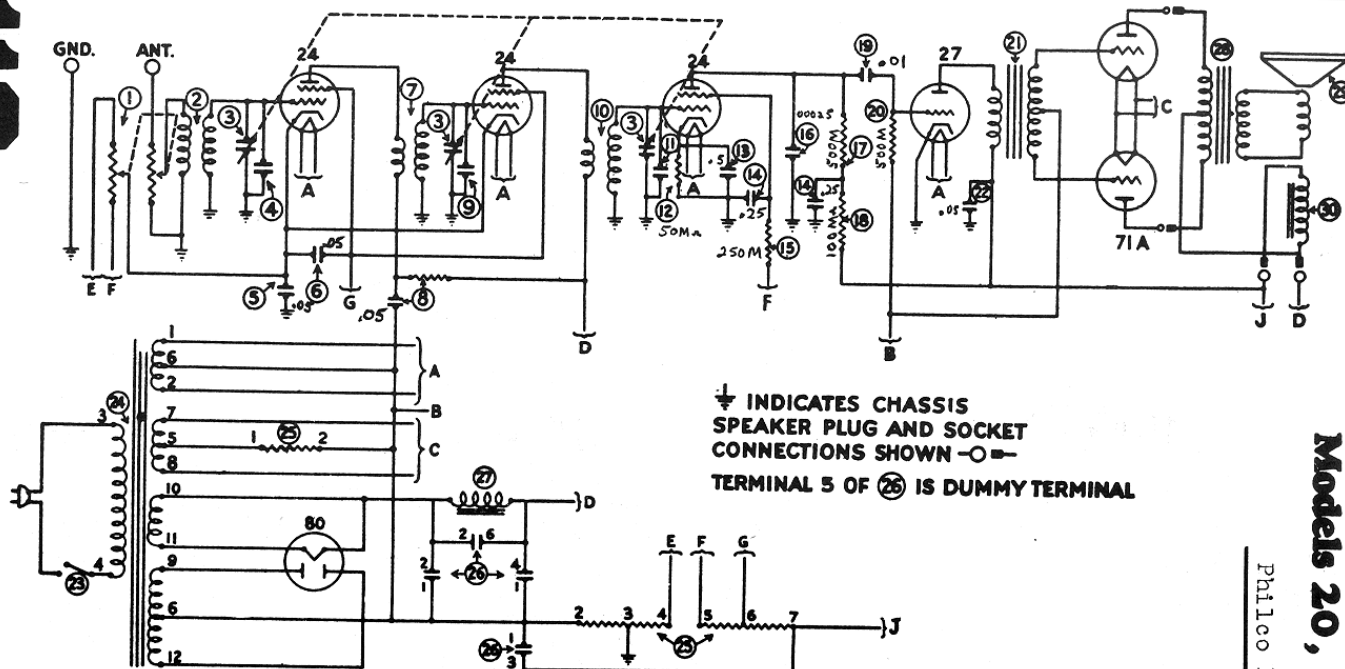
Models 20, 20-A and 21

No.	Description	Part No.
①	Volume Control	4094
②	First R. F. Transformer	3884-N
③	Tuning Condenser	4200-A
④	First Compensating Condenser (Part of Tuning Condenser Assembly)	
⑤	By-Pass Condenser (.05)	3615-J
⑥	By-Pass Condenser (.05)	3615-M
⑦	Second R. F. Transformer	3884-P
⑧	By-Pass Condenser (.05) and Resistor	3615-K
⑨	Second Compensating Condenser (Part of Tuning Condenser Assembly)	
⑩	Third R. F. Transformer	3884-P

⑪	Third Compensating Condenser (Part of Tuning Condenser Assembly)	
⑫	Resistor (50,000)	4237
⑬	By-Pass Condenser (.5)	3583
⑭	By-Pass Condenser (double .25)	3557
⑮	Resistor (250,000)	3768
⑯	By-Pass Condenser (.00025)	3082
⑰	Resistor (500,000)	3769
⑱	Resistor (100,000)	3767
⑲	Condenser (.01)	3903-F
⑳	Resistor (500,000)	3769
㉑	Push-pull Input Transformer	4232
㉒	By-Pass Condenser (.05)	3615-L
㉓	On-off Switch	4095

㉔	Power Transformer (50-60 cycle)	4234
㉕	Power Transformer (25-60 cycle)	4268
㉖	B. C. Resistor	4230
㉗	Filter Condenser (50-60 cycle)	4235
㉘	Filter Condenser (25-60 cycle)	4269
㉙	Filter Choke	4231
㉚	Push-Pull Output Transformer	2766
㉛	Voice Coil and Cone	2769-B
㉜	Field Coil	2768

Download a Schematic of the Radio Your are Restoring

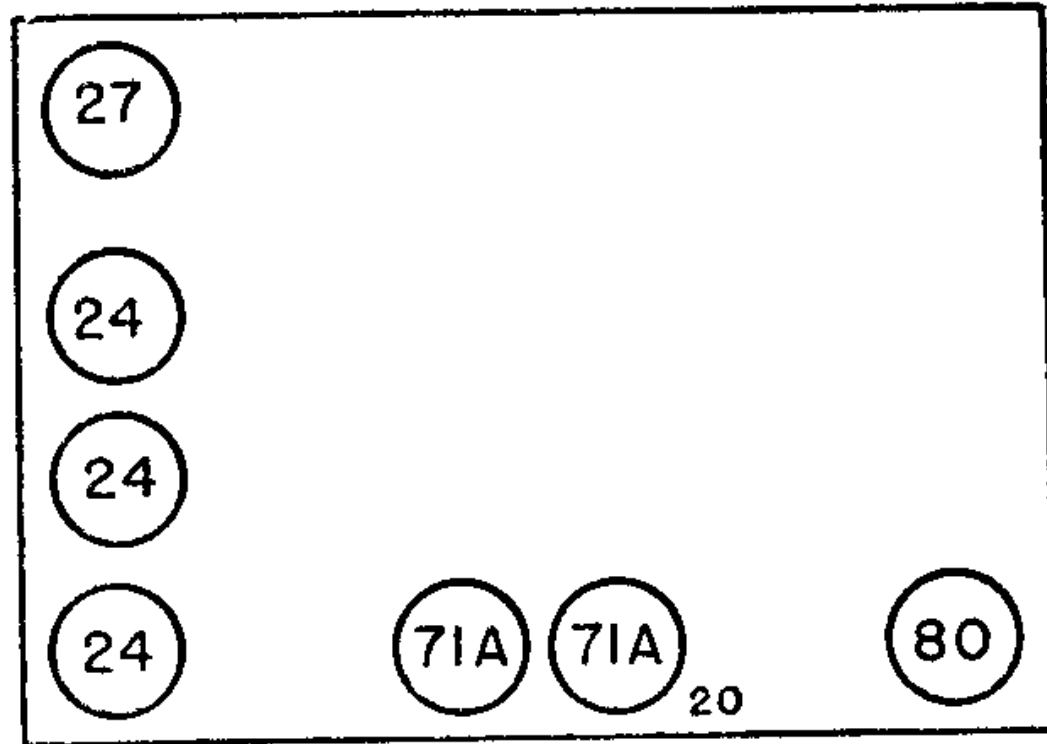
Tube Placement Chart

80 tube, subs
are 5Z3 & 83

24 tube, subs
are 35 & 51

27 tube,
sub is 56

71A tube,

Because the schematic did not include tube pin numbers, I added the pinouts from the web along with substitutes.

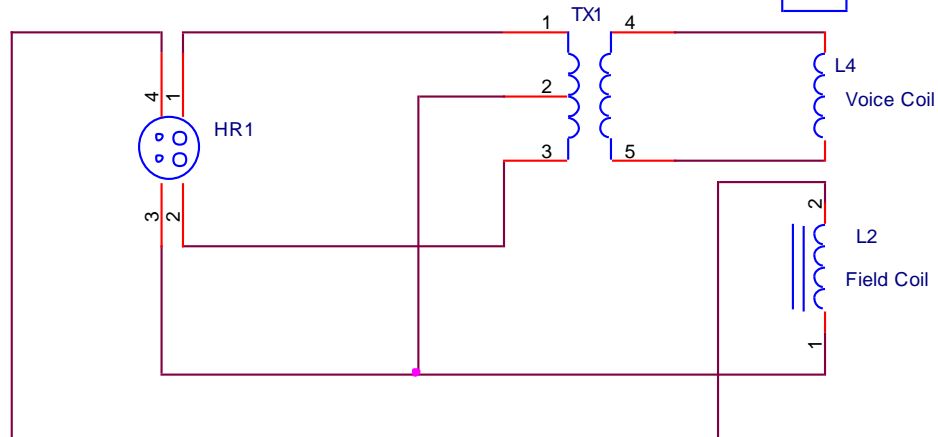
Figure 1. Speaker Plug Circuit

Speaker Plug looking at the pins

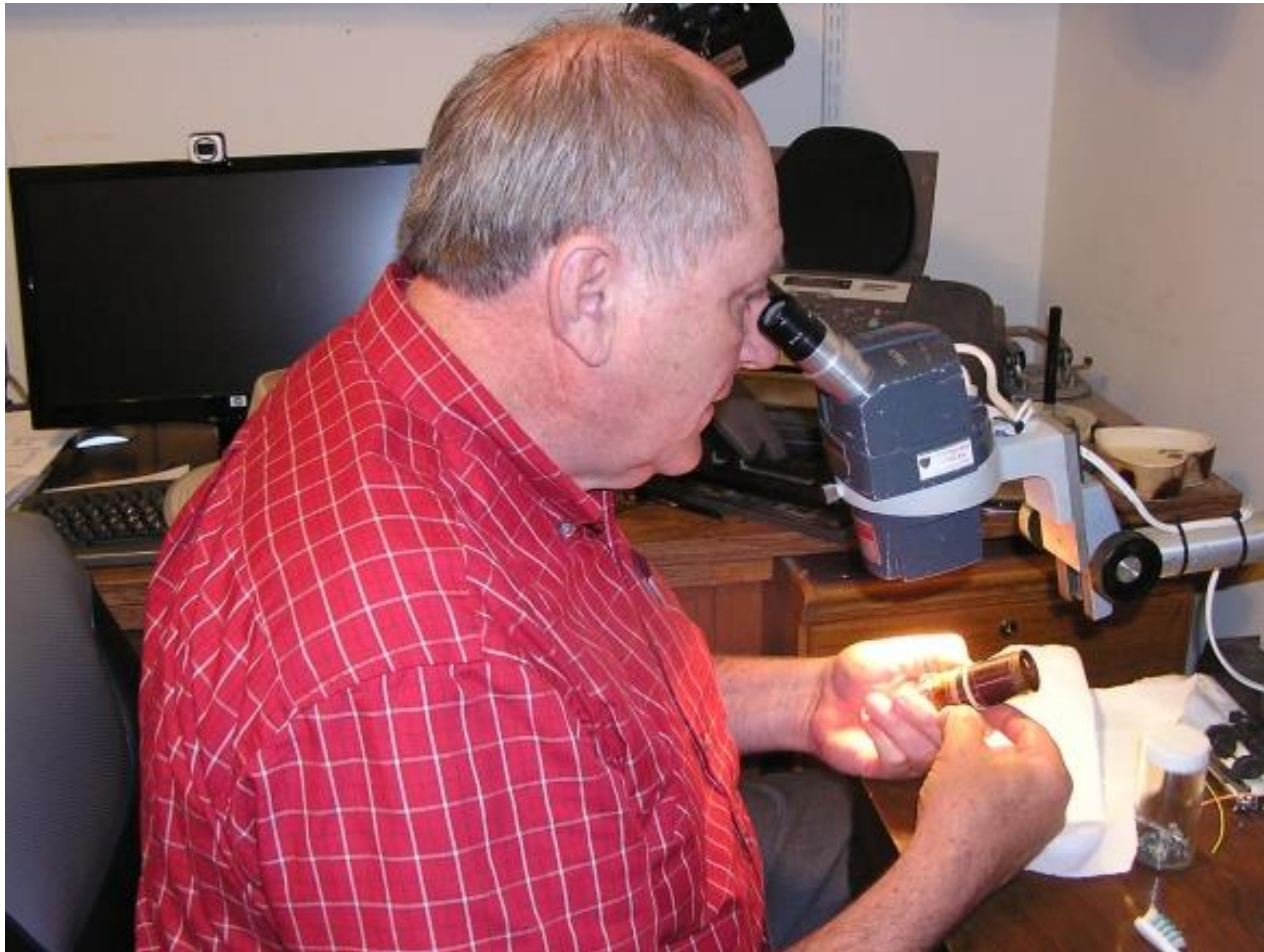
**Sometimes the task are really tedious like
rewinding the RF transformers**

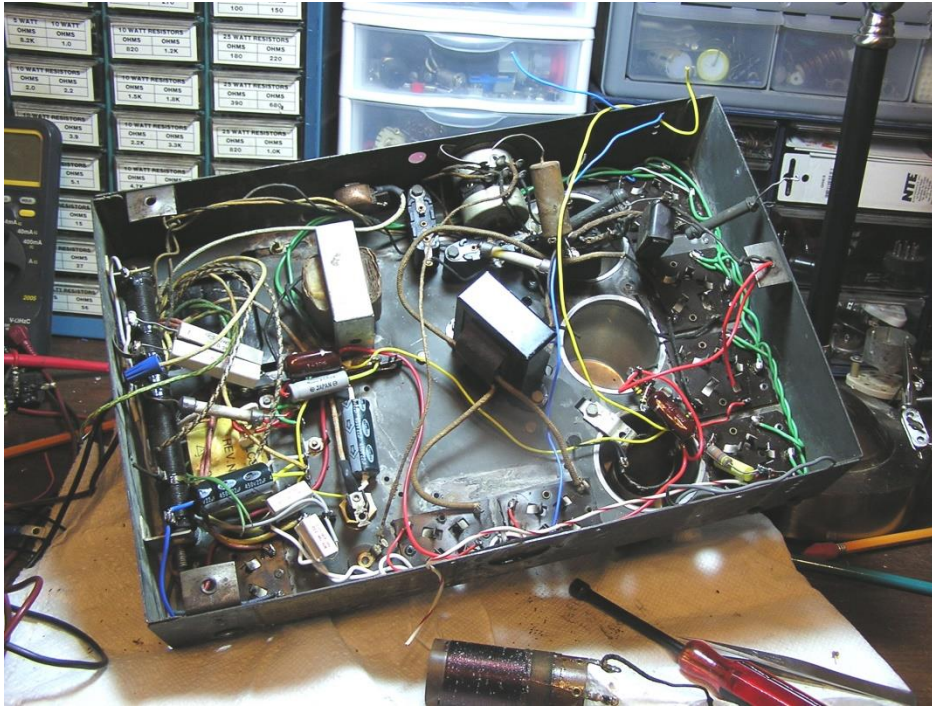
Ready to install the RF transformer
Back into its shield

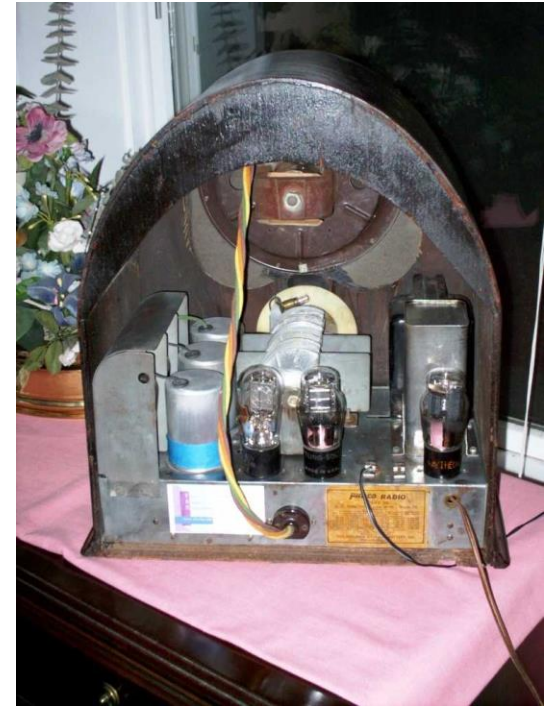
Fully functional chassis
back in its repaired
cabinet.
